4.5 CULTURAL RESOURCES

4.5.1 EXISTING CONDITIONS

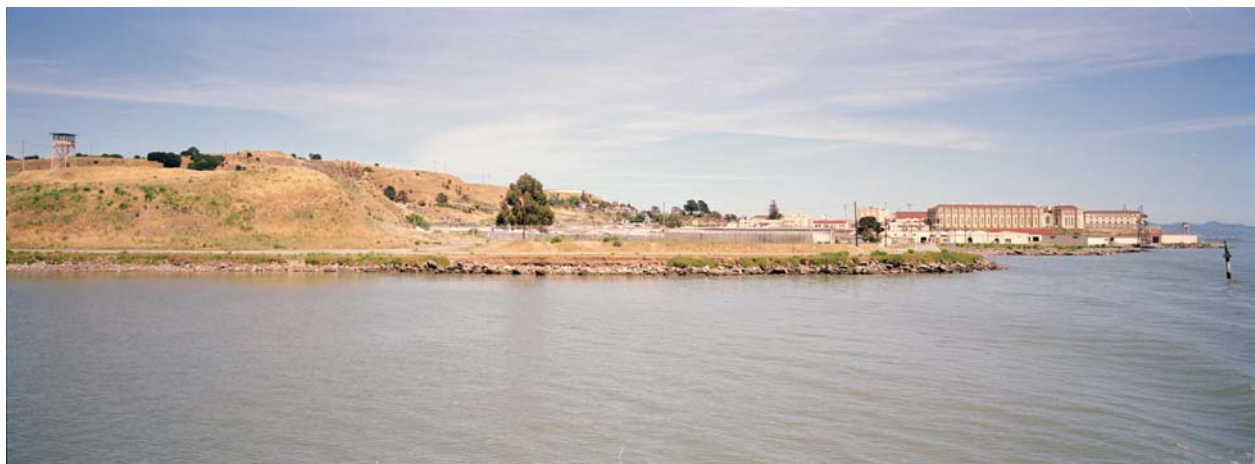
Exhibit 4.5-1 Existing view of project site in the foreground. The south and north cell blocks are visible in the background, to the right of frame.

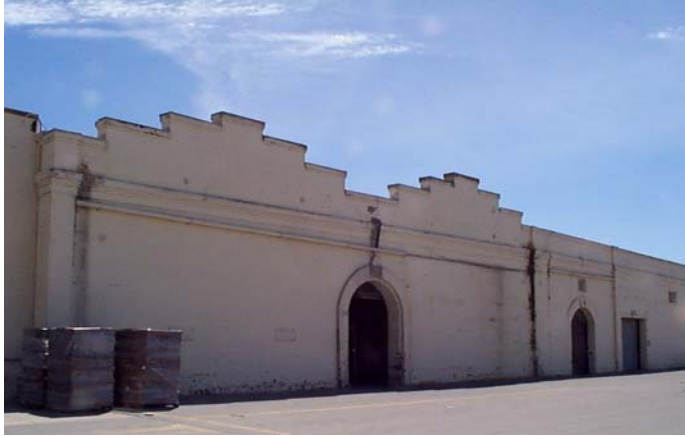
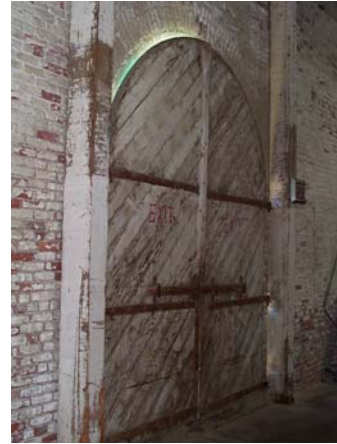
Exhibit 4.5-3 Warehouse 4 (with warehouse 2 and 3)

Warehouses 2, 3, and 4 (Exhibit 4.5-3) are located east of the project site outside the proposed development area. These buildings are historically significant because they are the oldest buildings remaining at SQSP. These buildings were used for loading and unloading of prison supplies and products from ships entering San Francisco Bay. As shown in Exhibit 4.5-2, there have been some alterations to the adjoining warehouse buildings, including stucco coating over brick, and conversion of a slightly pitched roof to a flat roof. However, these buildings have retained their historic character. Warehouse 4 has retained most of its historic character and, in comparison to the other warehouse buildings, is the most historically significant building. Warehouses 3 and 4 have arched door openings. Warehouse 4 has a roof parapet and pin hinges on interior doors, which are likely the original pins. The presence of several major cracks in warehouse 3 indicate that it may be seismic instable. Warehouse 2 has the least architectural significance, and has lost some integrity because it appears to have been shortened in the rear.

Warehouse buildings 2, 3, and 4 are located east of the project site adjacent to the existing prison facilities near the SQSP dock. These buildings are sufficiently distant from the project site that construction and operation activities would not alter or otherwise affect these buildings.

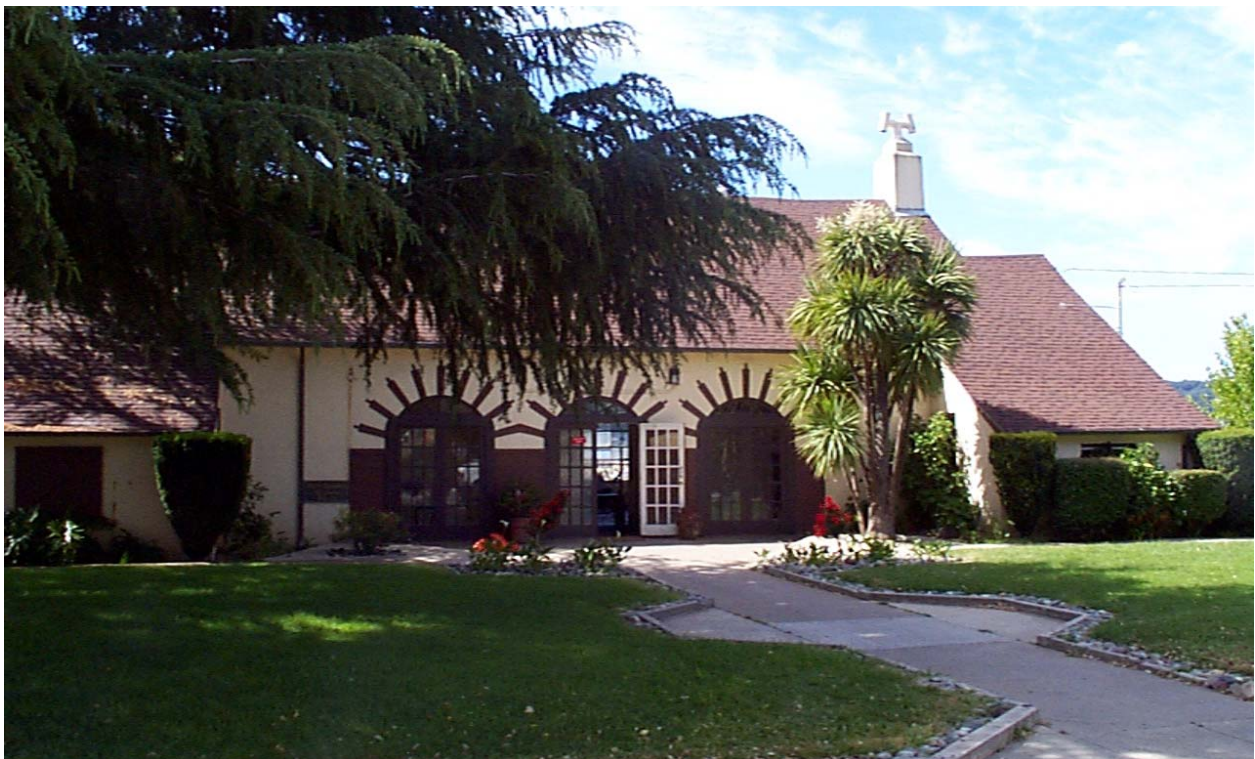
Exhibit 4.5-4. San Quentin Schoolhouse (Building 95, built 1923)

The San Quentin schoolhouse building (Exhibit 4.5-4) is located on Valley Way, in the northern portion of the project site. This schoolhouse was the third school constructed at SQSP. There have been very few exterior alterations to this building. Some windows have been replaced and the building has been re-roofed. The school closed in 1965 and the building is currently used as a recreational facility (i.e., gym). The current use resulted in some interior alterations. For example, carpet was installed in some rooms and some fixtures were replaced. There are granite walls with concrete caps serving as retaining walls on the southern elevation. The retaining wall is an attractive feature, but it is not a character-defining feature of the schoolhouse building because the original retaining walls were concrete, not stone. The schoolhouse is historically significant because of its architectural character, a blend of the Romanesque and English Revival style. Further, because there have been very few alterations to the schoolhouse over the years, it retains several aspects of integrity, including materials and workmanship as well as feeling and association. Although this was the third school constructed at SQSP, this is the only schoolhouse remaining on the prison grounds. As such, it is a visible reminder of the prison's facilitation of prison employees and their families.

Under the single level design option, project facilities would result in the demolition and removal of the schoolhouse building and the adjacent residences to the north. Because the schoolhouse appears eligible for listing as a historical resource in the CRHR, demolition and removal of this building would be a significant impact under this design option.

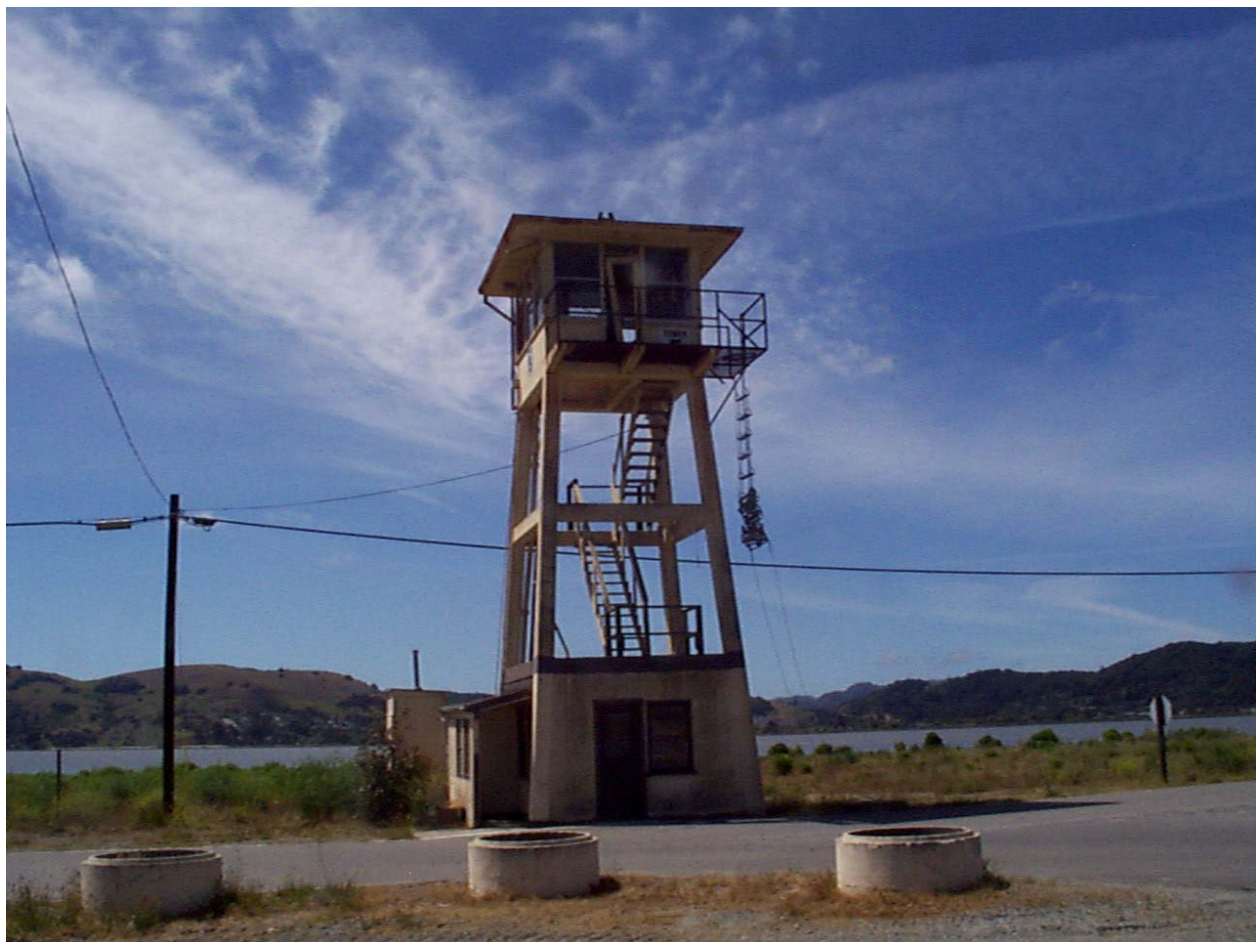
Exhibit 4.5-5. Tower 5 (Building T-5)

Tower 5 (Exhibit 4.5-5) was constructed along the shoreline of San Francisco Bay in 1946. This tower appears to have no apparent alterations. Tower 5 is historically significant because it is a resource type unique to a prison, was constructed within SQSP's period of significance, and retains all aspects of integrity.

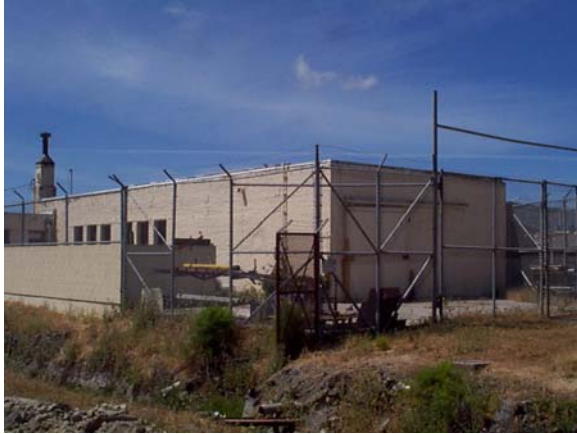
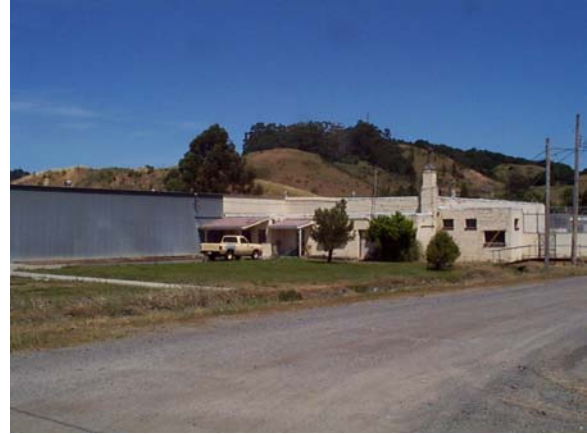
Exhibit 4.5-6. Detergent Plant/Old Slaughter House (Building 67)

The detergent plant/old slaughter house building (Exhibit 4.5-6) is located in the southern portion of the project site and has undergone several alternations. This facility ceased operations around 1988. There is evidence of long-term deterioration and neglect as a result of its discontinued use. This building was originally constructed in 1906, a corrugated metal addition was added to the building in 1961, and a concrete block wall addition on the east elevation was constructed more recently. The windows on the east side have been replaced with sash. A drainage ditch is located on the east side of the building. Even though this building is believed be the oldest agricultural building on the SQSP, the integrity of the construction materials, design, workmanship, feeling, and association have been substantially diminished. Therefore, this building would not qualify as a historical resource eligible for listing on the CRHR.

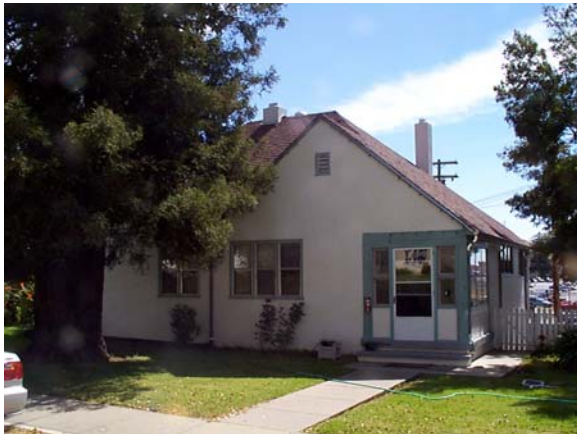
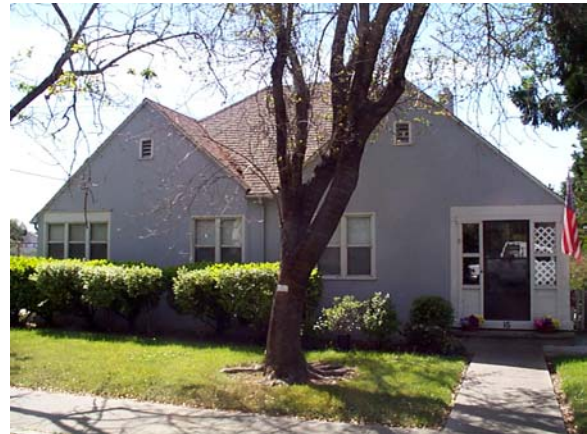
Exhibit 4.5-7. Staff Residences Located Along Valley Way

The staff residences (Exhibit 4.5-7) in the northern portion of the project site were constructed in 1926 of wood frame and stucco, generally in the English Revival style. All residences appear to have been altered by a porch enclosure, their windows replaced with aluminum sash, and some of their window openings were re-sized. A handicap access ramp was constructed over the entry stairs of residence 9. This

alteration appears to be reversible. Staff residences 1-13 (odd numbered) exhibit limited architectural quality and have lost some integrity of materials and design and are not individually significant historical resources. However, these homes may contribute to a historic district (consisting of SQSP staff residences on the project site) because of their architectural similarity and shared history. The potential for a historic district has not yet been established and is contingent upon further research and discussion with SHPO. Some other staff residences located along the north side of Valley Way were constructed circa 1912 in the Craftsman Bungalow style and exhibit a higher degree of architectural quality compared to staff residences 1-13 (odd numbered).

Under the single level design option, the 57 existing staff residences would need to be removed. CDC is consulting with SHPO to discuss the potential for these residences (collectively) to qualify as a historic district on the CRHR because of architectural similarity and share history. At this time it is unknown whether these residences would qualify as a historic district. Therefore, until SHPO makes a formal determination regarding the historic status of these residences, CDC has identified the removal of these residences as a potentially significant impact. If SHPO does not consider this to be a historic district, removal of these homes would be a less than significant cultural resource impact.

Under the stacked design option, the 57 existing staff residences would remain in place and a support services building, parking areas, and outer perimeter roadway would be constructed south of their location. The residences are located 10-20 feet above the plain where the CIC would be constructed. The closest facility proposed facilities(i.e., parking areas and support services building) would be located approximately 50 feet south of these residences and the closest building, 180 Degree Housing Unit, would be located approximately 130 feet south. The proposed facilities would be visible from some backyard areas of these residences; however, they would not materially alter, in an adverse manner, the physical characteristics of these buildings. Further, because all residences would remain in place, the integrity and unity of the potential historic district would be maintained. This design option would have a less than significant impact on the existing staff residences.

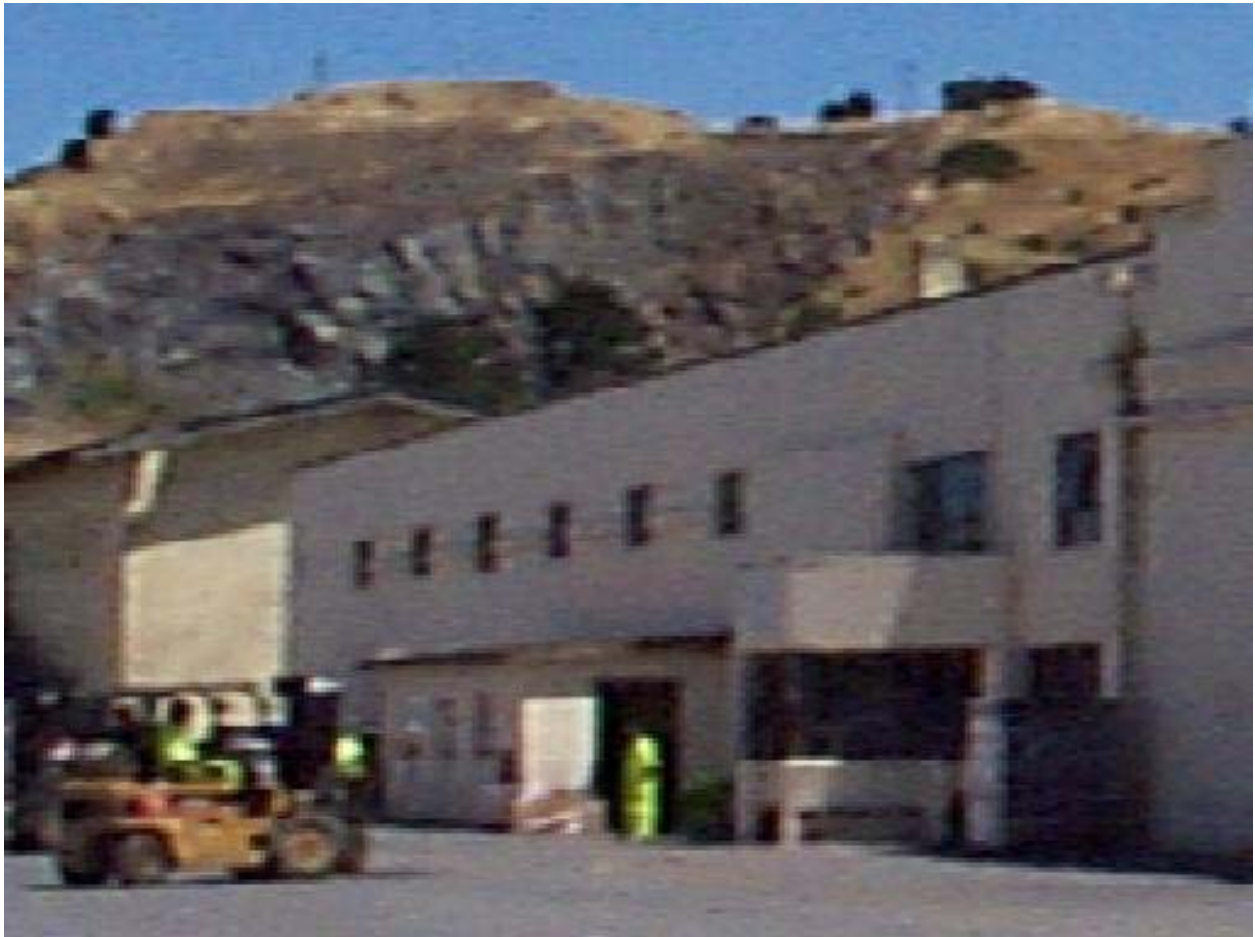
Exhibit 4.5-8. Warehouse 5 (portion of Building 50)

Warehouse 5 (Exhibit 4.5-8), located east of the project site, was constructed in 1933. This building appears to have been substantially altered with changes to the windows, doors, and loading area. Because this building does not represent the oldest warehouse building at SQSP, and lacks sufficient architectural quality and integrity, it would not qualify for listing on the CRHR.

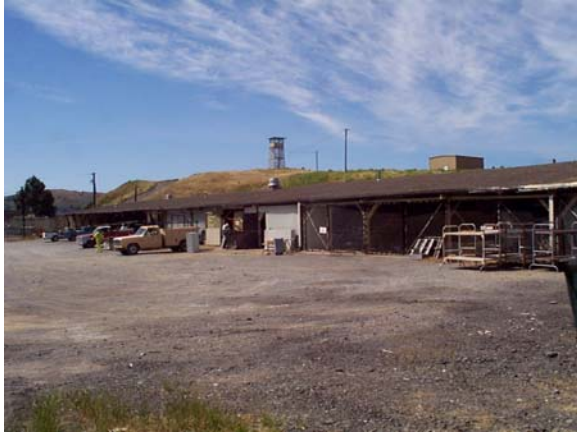
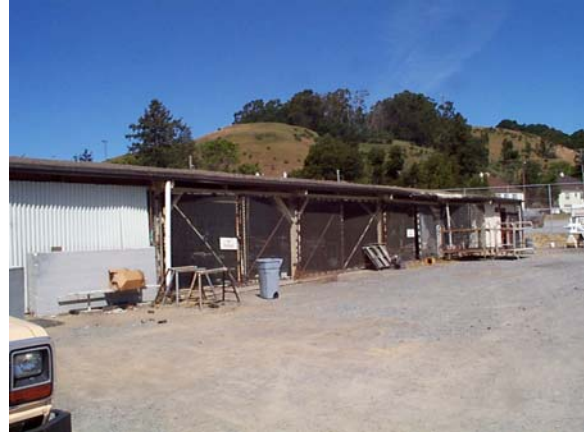
Exhibit 4.5-9. Dairy Building (Building 76)

The dairy building (Exhibit 4.5-9), located within the project site, was constructed in 1936 and has undergone several alterations including partitioning for internal rooms. The dairy, chicken ranch, and hog ranch was operated by members of the Jordon family until 1966. This family is not viewed as having been important either in the prison history or California history. The windows, siding, and doors of the building have been replaced. There is chain link infill in portions of the building. This building is currently used as a shop. Because of the alterations and its lack of architectural quality and integrity, this building would not qualify for listing on the CRHR.

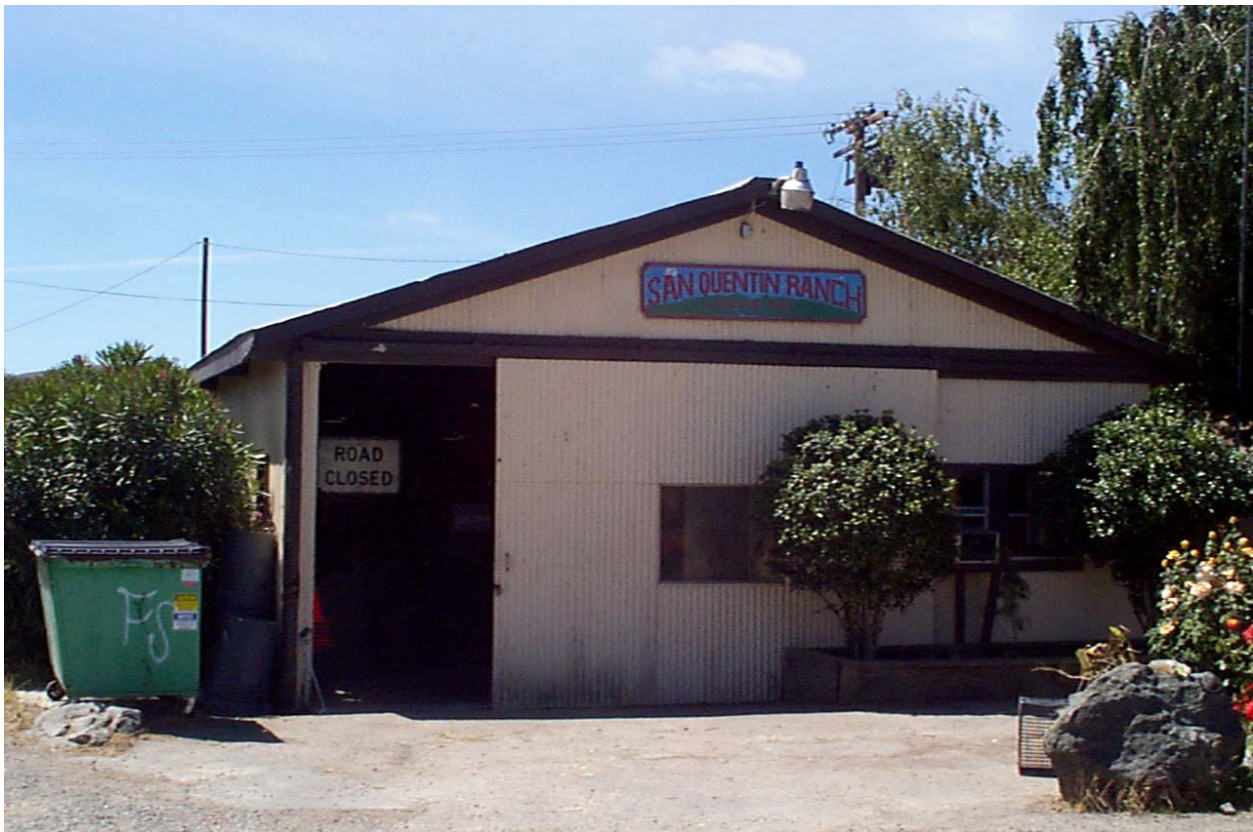
Exhibit 4.5-10. Landscaping Department Building/Out Grounds/Green House (Building 65)

The landscaping department building (Exhibit 4.5-10), located within the project site, was constructed in 1938. This building has a full panel corrugated metal sliding door and sash windows. While it largely retains integrity from its construction in 1938, it lacks adequate architectural quality or historical significance to qualify for listing on the CRHR.

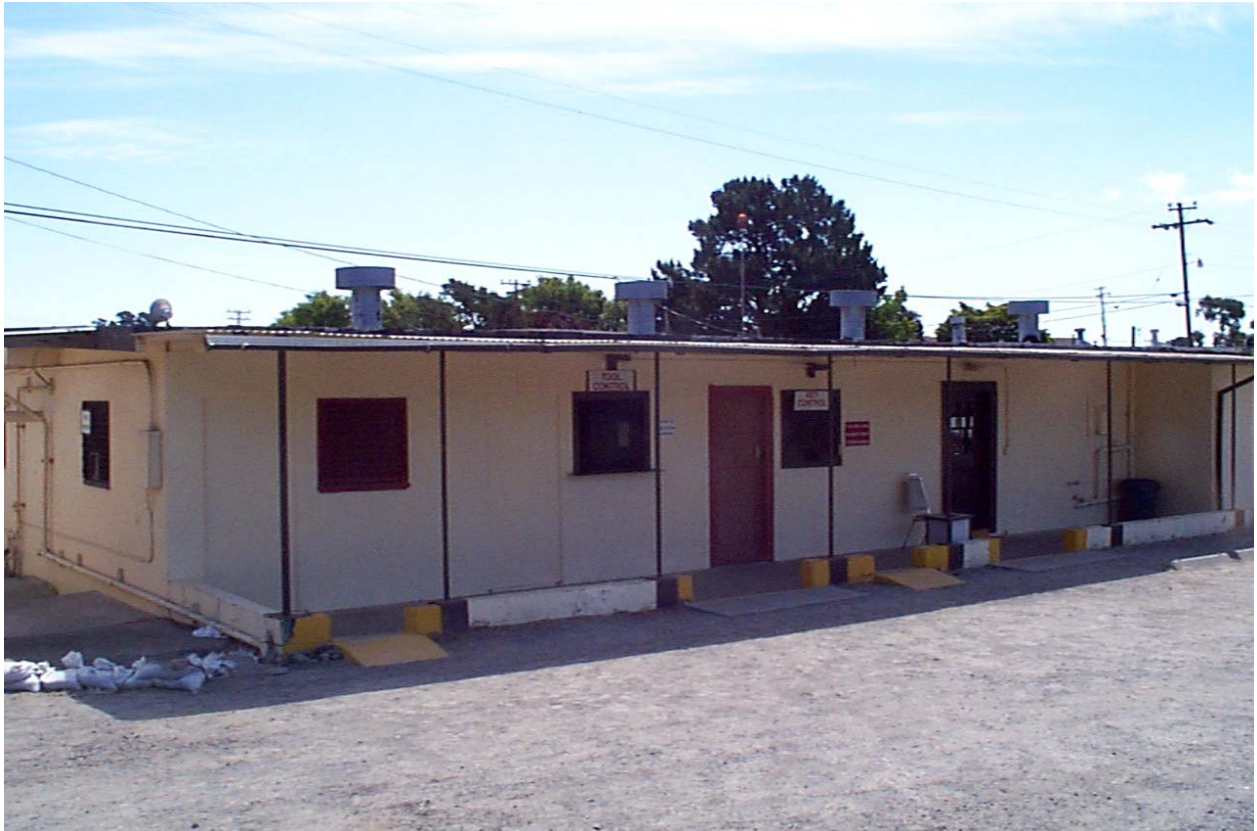
Exhibit 4.5-11. Tool Control/Old Veterinary Building (Building 73)

The tool control/old veterinary building (Exhibit 4.5-11), located across from the dairy building, was constructed in 1950. Some windows have been replaced, but overall this building retains all aspects of integrity. However, it does not have sufficient architectural character or historical significance to qualify for listing on the CRHR.

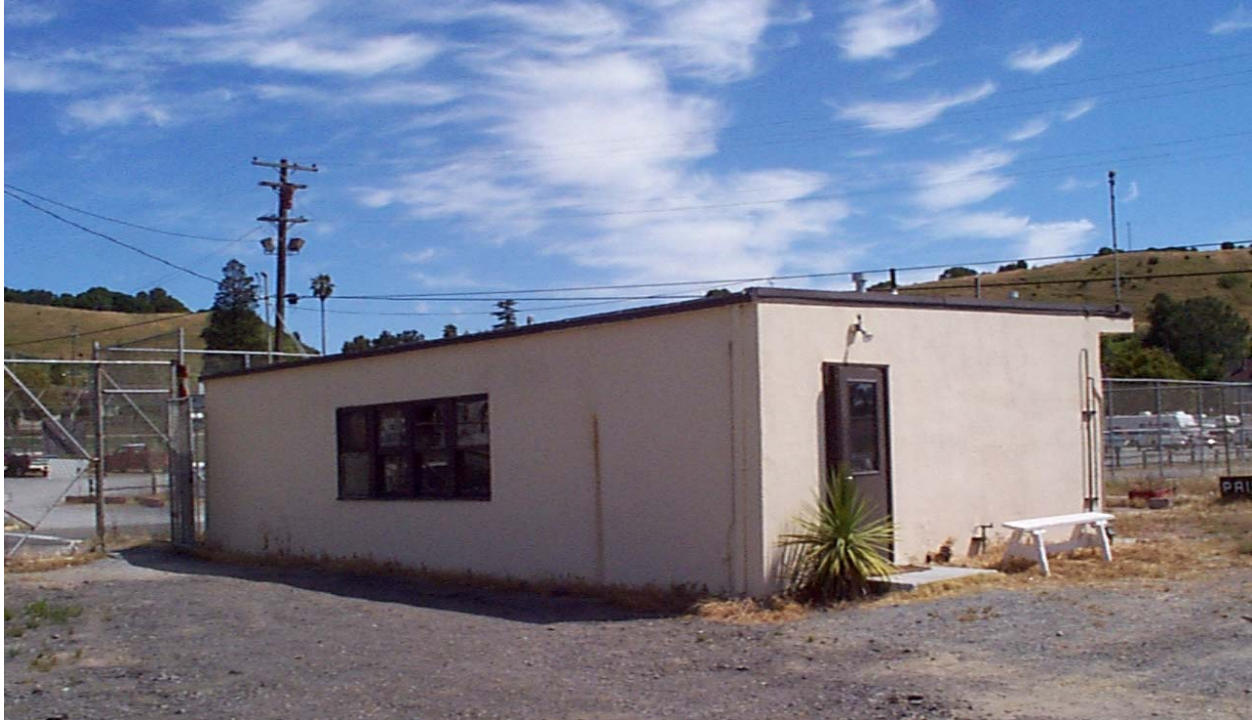
Exhibit 4.5-12 Old Butcher Shop Building, near Dairy Building (Building 76)

The old butcher shop building (Exhibit 4.5-12), located within the project site, was constructed in 1950. This building appears to have been layered with stucco and converted to office uses. It lacks sufficient architectural quality and integrity to qualify for listing on the CRHR.

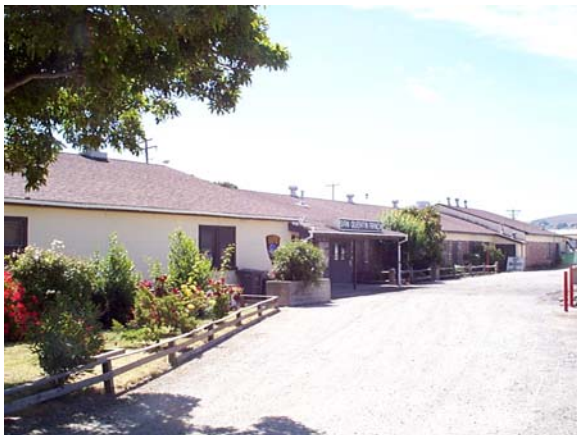
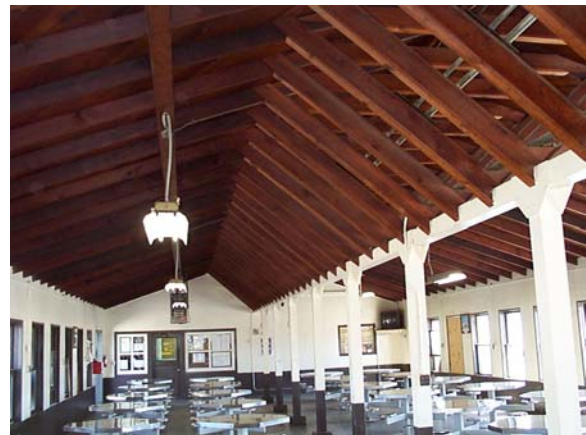
Exhibit 4.5-13 Ranch Kitchen/Dining Hall (Building 71)

The Ranch kitchen/dining hall (Exhibit 4.5-13), located in the center of the project site, was constructed in 1950. The character defining features include sash windows and decorative truss and wood paneled ceiling. It appears that there have been several incompatible additions to this building including a concrete block addition on the south façade and a wood panel exterior addition on the southern elevation, adjacent to the kitchen. Some of the building doors have been replaced over the years. Even though the Ranch kitchen/dining hall has some attractive interior elements and was constructed within SQSP's period of significance, the multiple additions have diminished its integrity such that it would not qualify for listing on the CRHR.

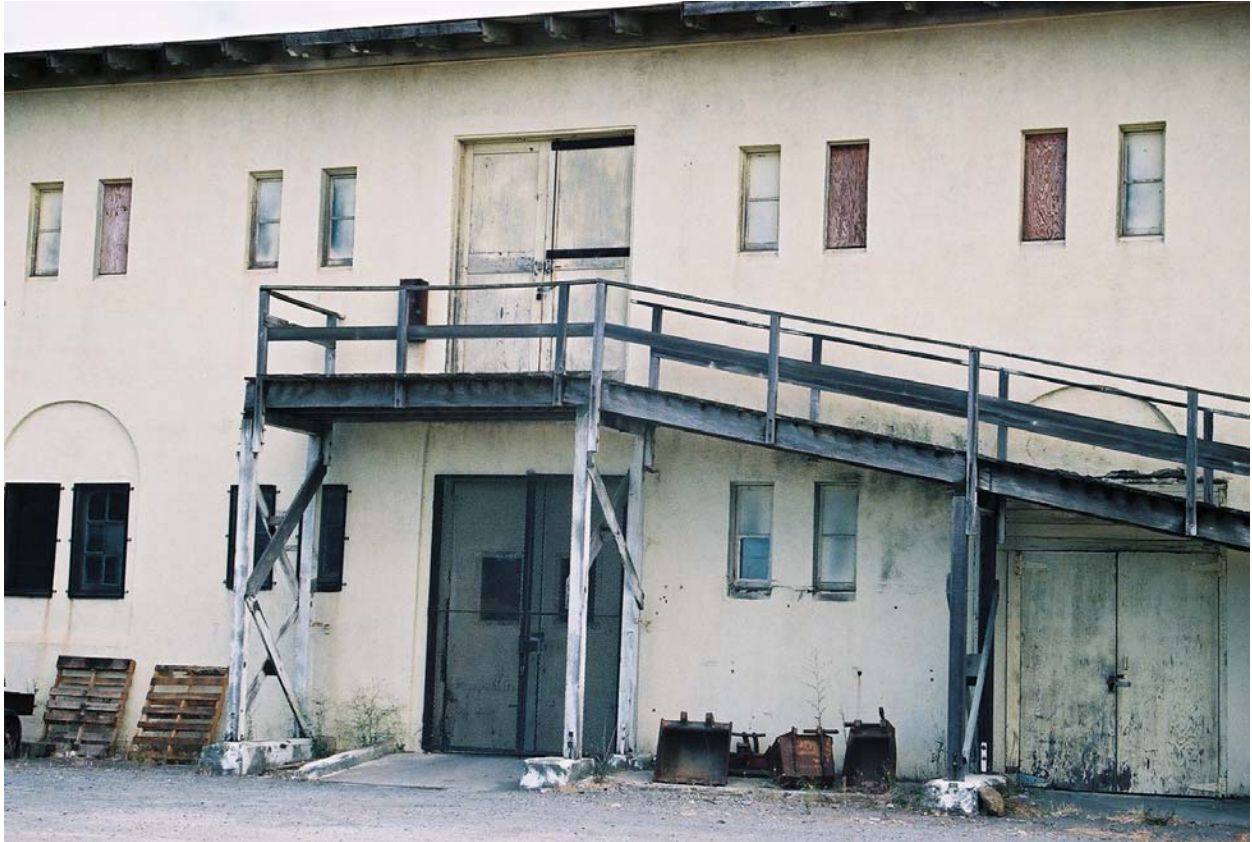
Exhibit 4.5-14. Old Barn (Building 51)

The old barn (Exhibit 4.5-14), located east of the project site, was constructed c.1913. The building has had several uses over the years, including having served as a barn and a repair shop. The building was converted to office use in 1991 and is currently used for storage. Alterations include the removal of most of the interior stalls, the construction of a staircase, and the creation of an entryway on the northern portion of the building. The exterior ramp is not original and appears to have been rebuilt within the past 20 years. This building lacks sufficient integrity and architectural quality to qualify for listing on the CRHR.

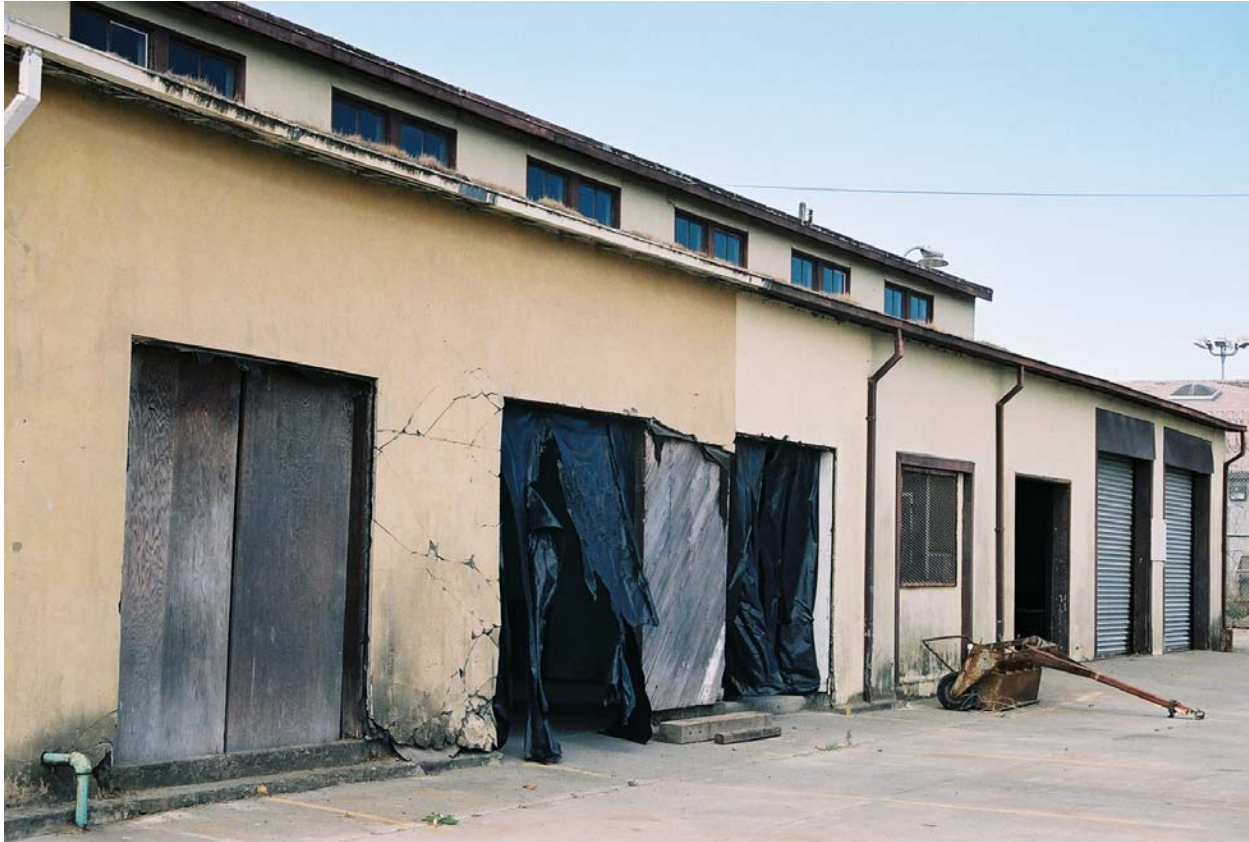
Exhibit 4.5-15. Old Garage (Building 54)

Building 54 (Exhibit 4.5-15) is located east of the project site. This building was constructed in 1944 as a garage. The west end of the building was rehabbed ca. 1990 to facilitate a vocational auto instruction program. Most of the modifications were undertaken on the interior of the building, including the addition of more rooms. Metal roll-up doors were added on the exterior. This building is now used for storage. Several major cracks may indicate seismic instability. This building lacks sufficient architectural character and historical significance to qualify for listing on the CRHR.

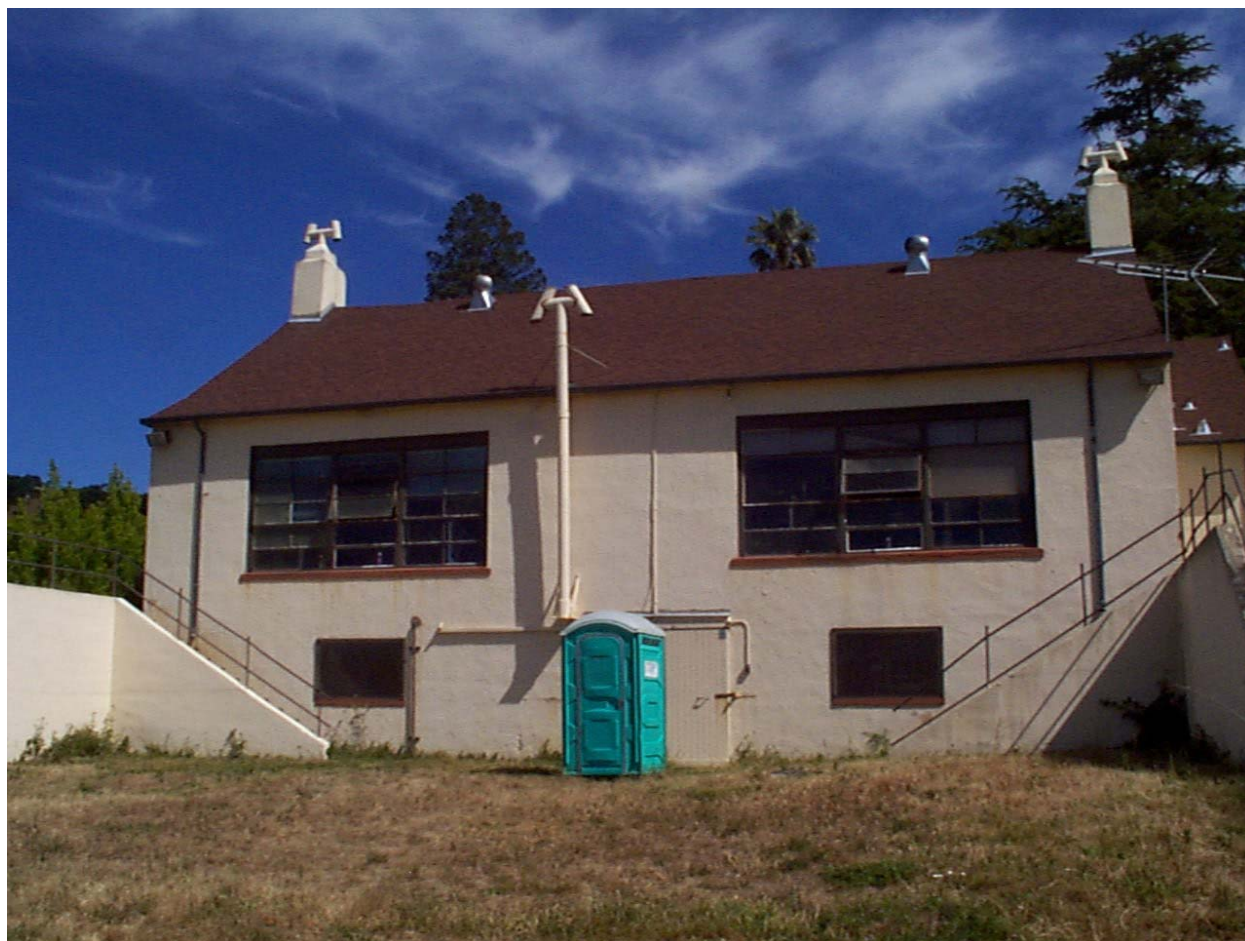
Exhibit 4.5-16. View toward the rear of the schoolhouse.

Under the stacked design option, the schoolhouse building would remain in place and a support services building, parking areas, and outer perimeter roadway would be constructed south of the schoolhouse building. The schoolhouse is located on a bluff approximately 10 feet above the plain where the CIC would be constructed. Exhibit 4.5-16 presents a view of the rear of the schoolhouse. Under the stacked design option, the closest facility (i.e., parking areas and support services building) of the CIC would be located approximately 30 feet south (rear) of the schoolhouse, and the closest building, 180 Degree

Housing Unit, would be located approximately 110 feet south of the schoolhouse. The height of the stacked housing unit (the tallest solid structure at the site) would be approximately 44 feet above the ground surface. Because of the 10 foot topographical height differential between the location of this building and the schoolhouse (10 feet higher in elevation), the height of housing unit, relative to the ground level of the schoolhouse would be 40 feet for the stacked design option. When viewing the schoolhouse from Valley Way (north of the schoolhouse), the housing units would be partially visible under this design option, however, they would not materially alter, in an adverse manner, the physical characteristics that convey the historical significance of the schoolhouse and would not cause a substantial adverse change in the significance of the building.
